# Sewer Inspection Report

1815 Pampas Ave, Santa Barbara, CA 93101, USA  
#8349

Aug. 20, 2025

Jesse Aizenstat #8349  
Cojo Canyon Plumbing

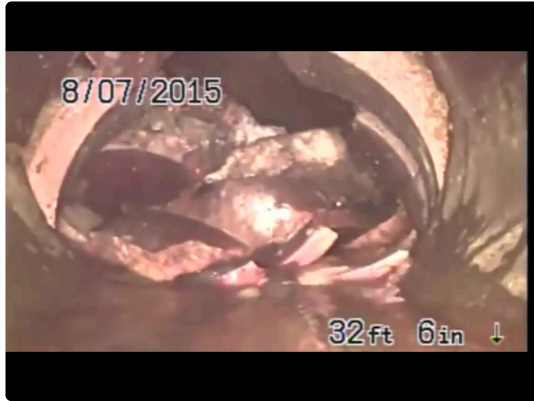
## Observation #1

3.76 seconds | 32.0 feet |  
COLLAPSE

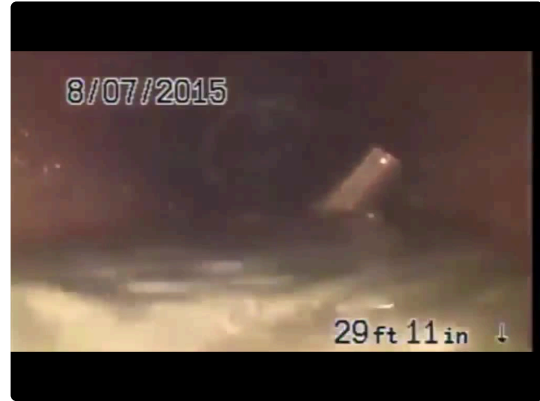
## Observation #2

12.31 seconds | 29.0 feet |  
BROKEN
