# Sewer Inspection Report

1815 Pampas Ave, Santa Barbara, CA 93101, USA

Aug. 20, 2025

Jesse Aizenstat  
Cojo Canyon Plumbing

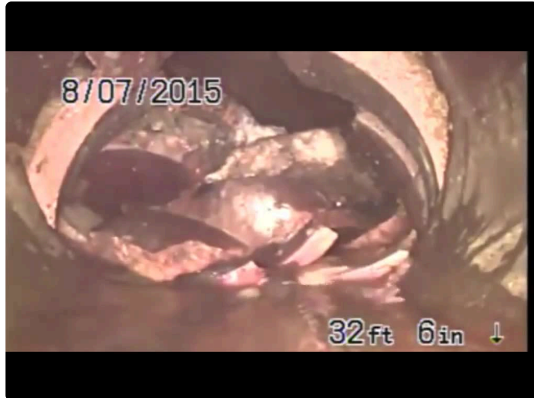
## Observation #1

Big collapse. Fix needed.

3.76 seconds | 32.0 feet |  
COLLAPSE

The sewer lateral inspection at 1815 Pampas Ave reveals multiple significant defects including collapse, broken pipe, offset joints, and root intrusion, all of which violate Santa Barbara Municipal Code Section 34.324 regarding sewer lateral condition and maintenance standards. The pipe material is cast iron, 4 inches in diameter, with a total length of 55 feet, and the inspection was conducted against flow. The presence of these defects indicates the lateral is not functioning properly and is not up to municipal code requirements. The City of Santa Barbara has determined that the sewer lateral requires replacement due to these deficiencies. Therefore, the inspection status is Needs Additional Work. Next steps: - Get multiple bids with plumbing contractors by forwarding the URL link on Forward Lateral. - Select a plumbing contractor and pull permits. - Perform the necessary sewer lateral replacement or repair. - Schedule or submit a final inspection with the City of Santa Barbara to confirm compliance.

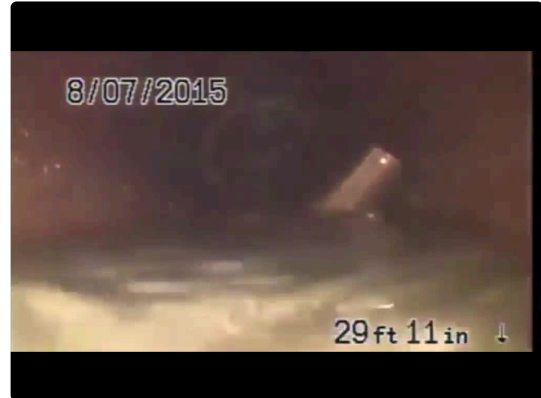
## Observation #2

12.31 seconds | 29.0 feet |  
BROKEN
