Sewer Lateral Report

2532 Borton Dr, Santa Barbara, CA 93109
#8821

About Your Sewer Lateral

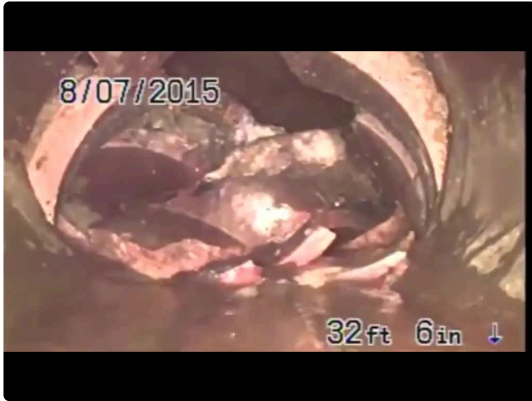
Observation #1

0.46 seconds | 32.6 feet |
COLLAPSE

- Get multiple bids with plumbing contractors by forwarding the URL link on Forward Lateral.
- Select a plumbing contractor and pull permits.
- Perform the necessary repairs to address collapse, offset, broken pipe, and root intrusion.
- Schedule or submit a final inspection with the City of Santa

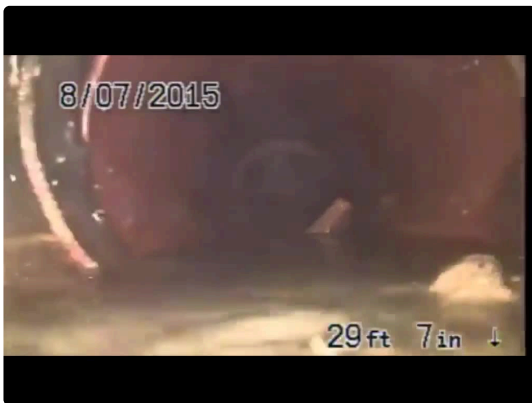
Observation #3

13.55 seconds | 29.0 feet |
BROKEN

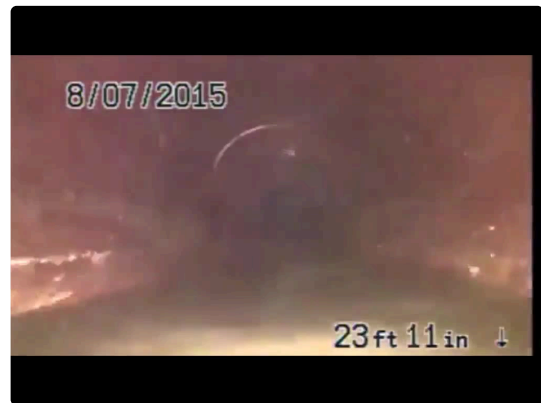
Observation #4

21.95 seconds | 22.0 feet |
ROOTS_25
