Sewer Inspection Report

2532 Borton Dr, Santa Barbara, CA 93109, USA
#8821

Jesse Aizenstat #8821
Cojo Canyon Plumbing

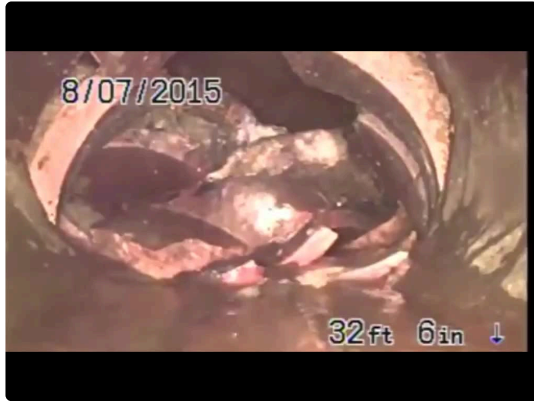
Observation #1

0.46 seconds | 32.6 feet |
COLLAPSE

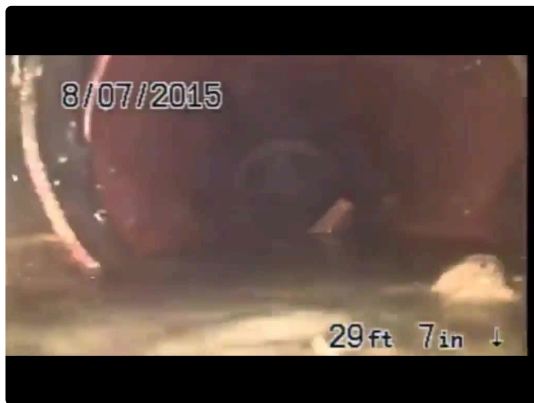
Observation #3

13.55 seconds | 29.0 feet |
BROKEN

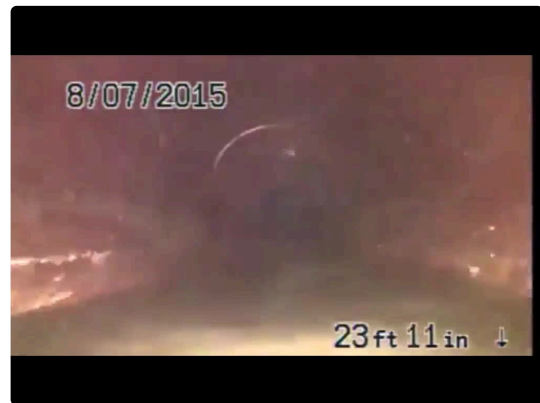
Observation #4

21.95 seconds | 22.0 feet |
ROOTS_25

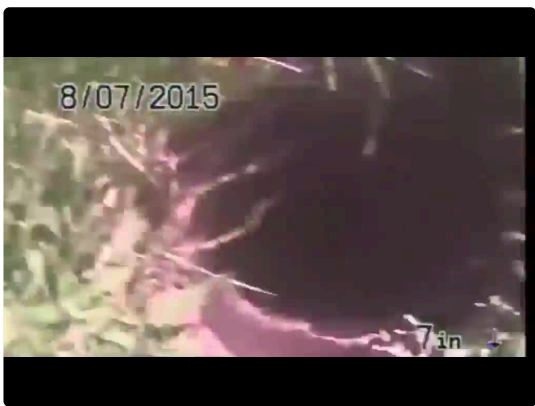
Observation #7

48.03 seconds | CLEAN_OUT
