Sewer Lateral Report

1815 Pampas Ave, Santa Barbara, CA 93101
#8349

Jesse Aizenstat #8349
Cojo Canyon Plumbing

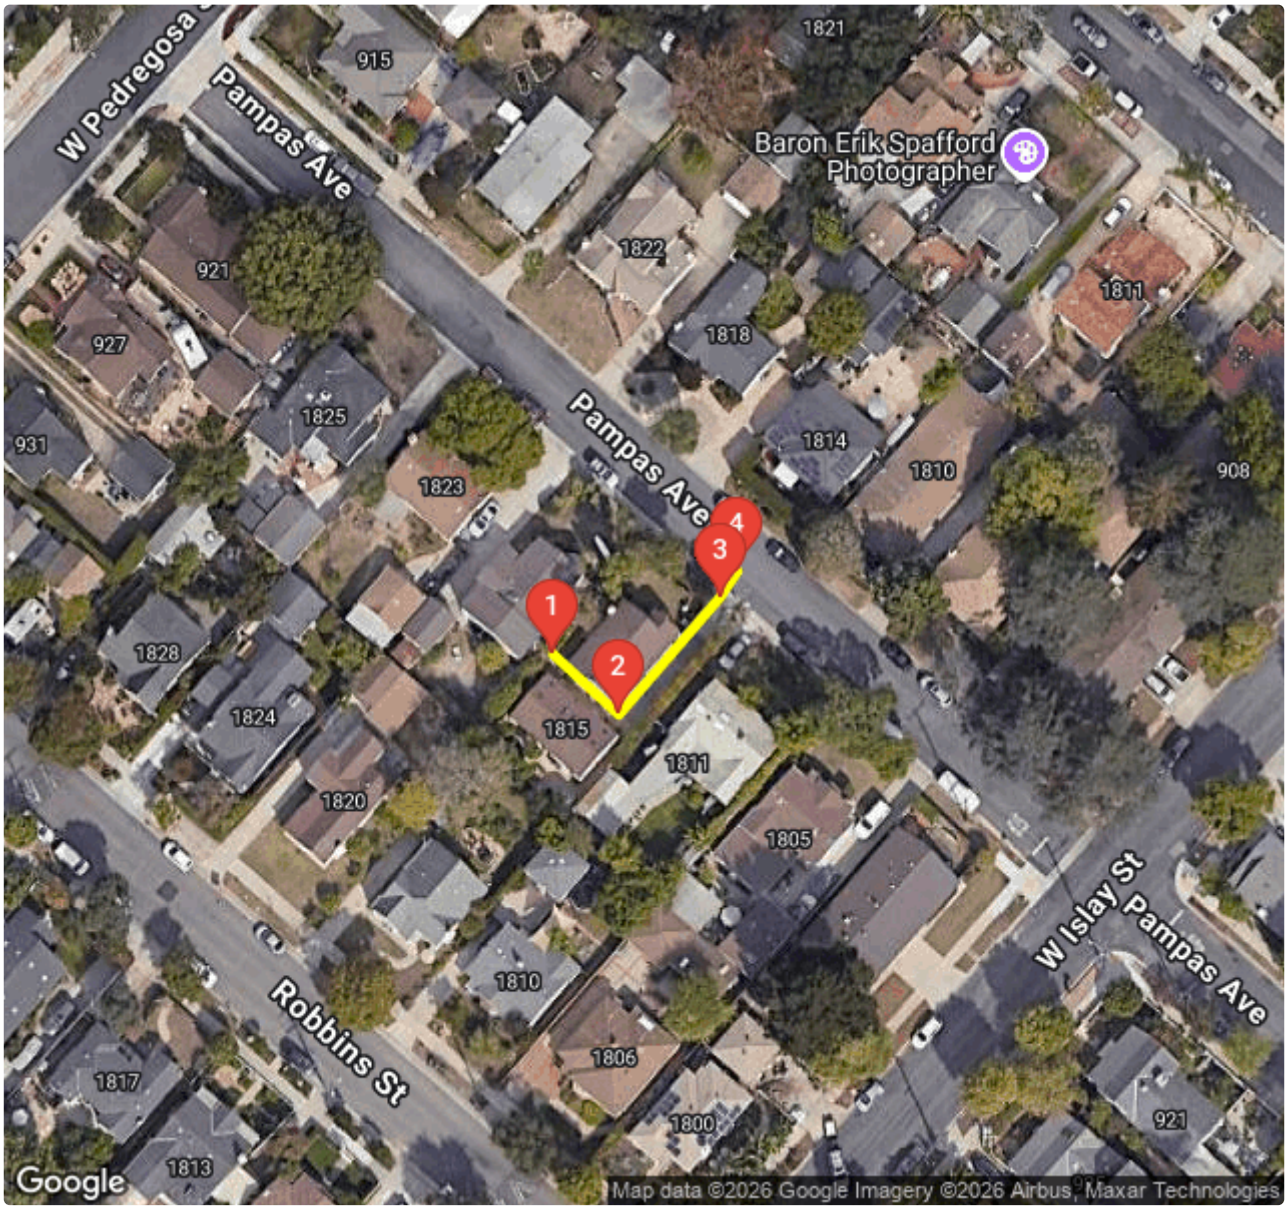
Property Map

1. **Lateral Start**
2. **ADU cleanout**
3. **Prop line cleanout**
4. **Y connection**

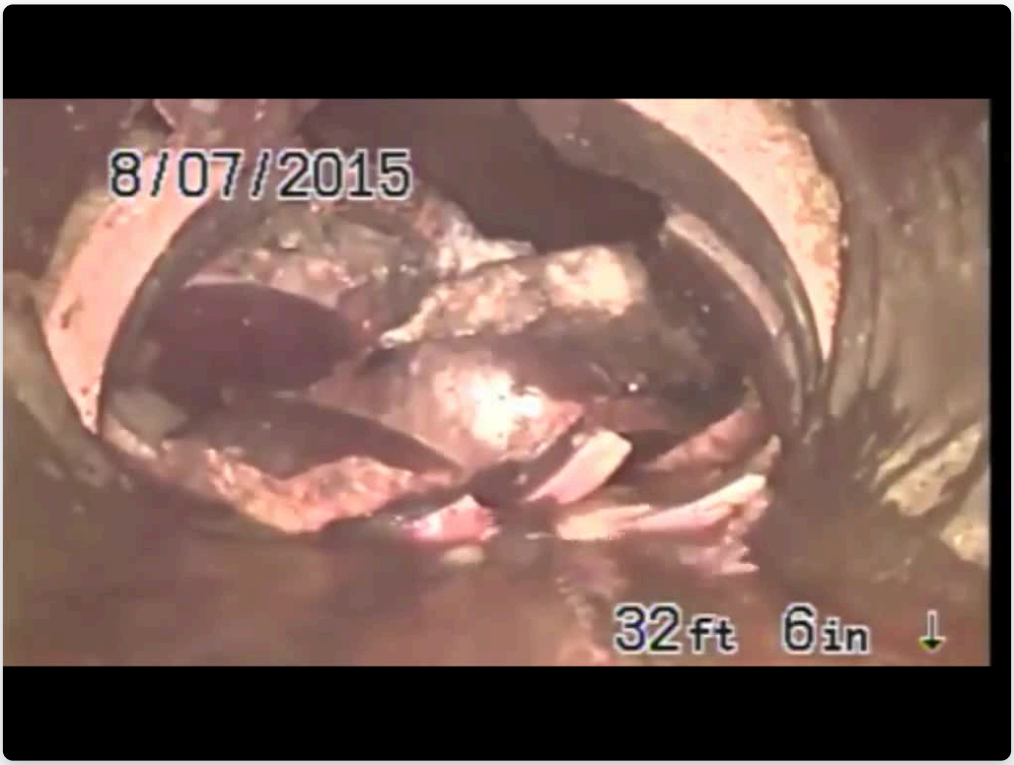
Sewer Lateral Video

Observation #1
3.76 seconds | 32.0 feet | COLLAPSE

Observation #2
12.31 seconds | 29.0 feet | BROKEN

Observation #3
37.33 seconds | 14.0 feet | OFFSET

Observation #4
39.65 seconds | 12.0 feet | ROOTS

The sewer lateral inspection at 1815 Pampas Ave reveals multiple significant defects including collapse, broken pipe, offset joints, and root intrusion, all of which violate Santa Barbara Municipal Code Section 34.324 regarding sewer lateral condition and maintenance standards. The pipe material is cast iron, 4 inches in diameter, with a total length of 55 feet, and the inspection was conducted against flow. The presence of these defects indicates the lateral is not functioning properly and is not up to municipal code requirements.

The City of Santa Barbara has determined that the sewer lateral requires replacement due to these deficiencies. Therefore, the inspection status is Needs Additional Work.

Next steps:
- Get multiple bids with plumbing contractors by forwarding the URL link on Forward Lateral.
- Select a plumbing contractor and pull permits.
- Perform the necessary sewer lateral replacement or repair.
- Schedule or submit a final inspection with the City of Santa Barbara to confirm compliance.
