Sewer Lateral Report

2532 Borton Dr, Santa Barbara, CA 93109
#8821

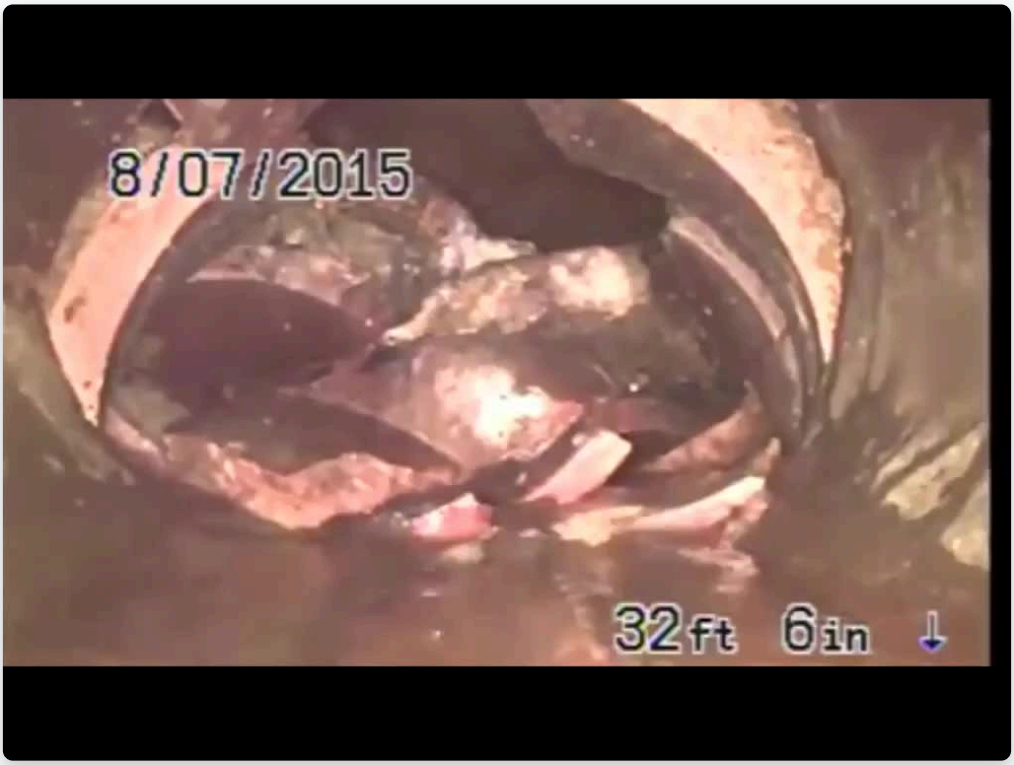
Sewer Lateral Video

Some big roots in there and a collapse.

Observation #1
0.46 seconds | 32.6 feet | COLLAPSE

Observation #2
10.89 seconds | 30.0 feet | OFFSET

Observation #3
13.55 seconds | 29.0 feet | BROKEN

Observation #4
21.95 seconds | 22.0 feet | ROOTS_25

Observation #5
32.77 seconds | 16.0 feet | ROOTS

Observation #6
37.18 seconds | 14.0 feet | ROOTS_50

The sewer lateral inspection at 2532 Borton Dr reveals multiple significant defects including a collapse, offset, broken pipe, and extensive root intrusion (25% to 50%) along the lateral. These conditions violate the Santa Barbara Municipal Code requirements for sewer lateral integrity and functionality, which mandate that laterals be free of structural damage and obstructions to prevent sewage leakage and backups.

Due to these defects, the inspection does not pass and the lateral requires repair to comply with municipal standards. The presence of a cleanout accessible outside the building and at the sidewalk is positive, facilitating repair work.

Next steps:
- Get multiple bids with plumbing contractors by forwarding the URL link on Forward Lateral.
- Select a plumbing contractor and pull permits.
- Perform the necessary repairs to address collapse, offset, broken pipe, and root intrusion.
- Schedule or submit a final inspection with the City of Santa

Barbara to confirm compliance.
