# Sewer Inspection Report

1815 Pampas Ave, Santa Barbara, CA 93101, USA  
#8349

Aug. 20, 2025

Jesse Aizenstat #8349  
Cojo Canyon Plumbing

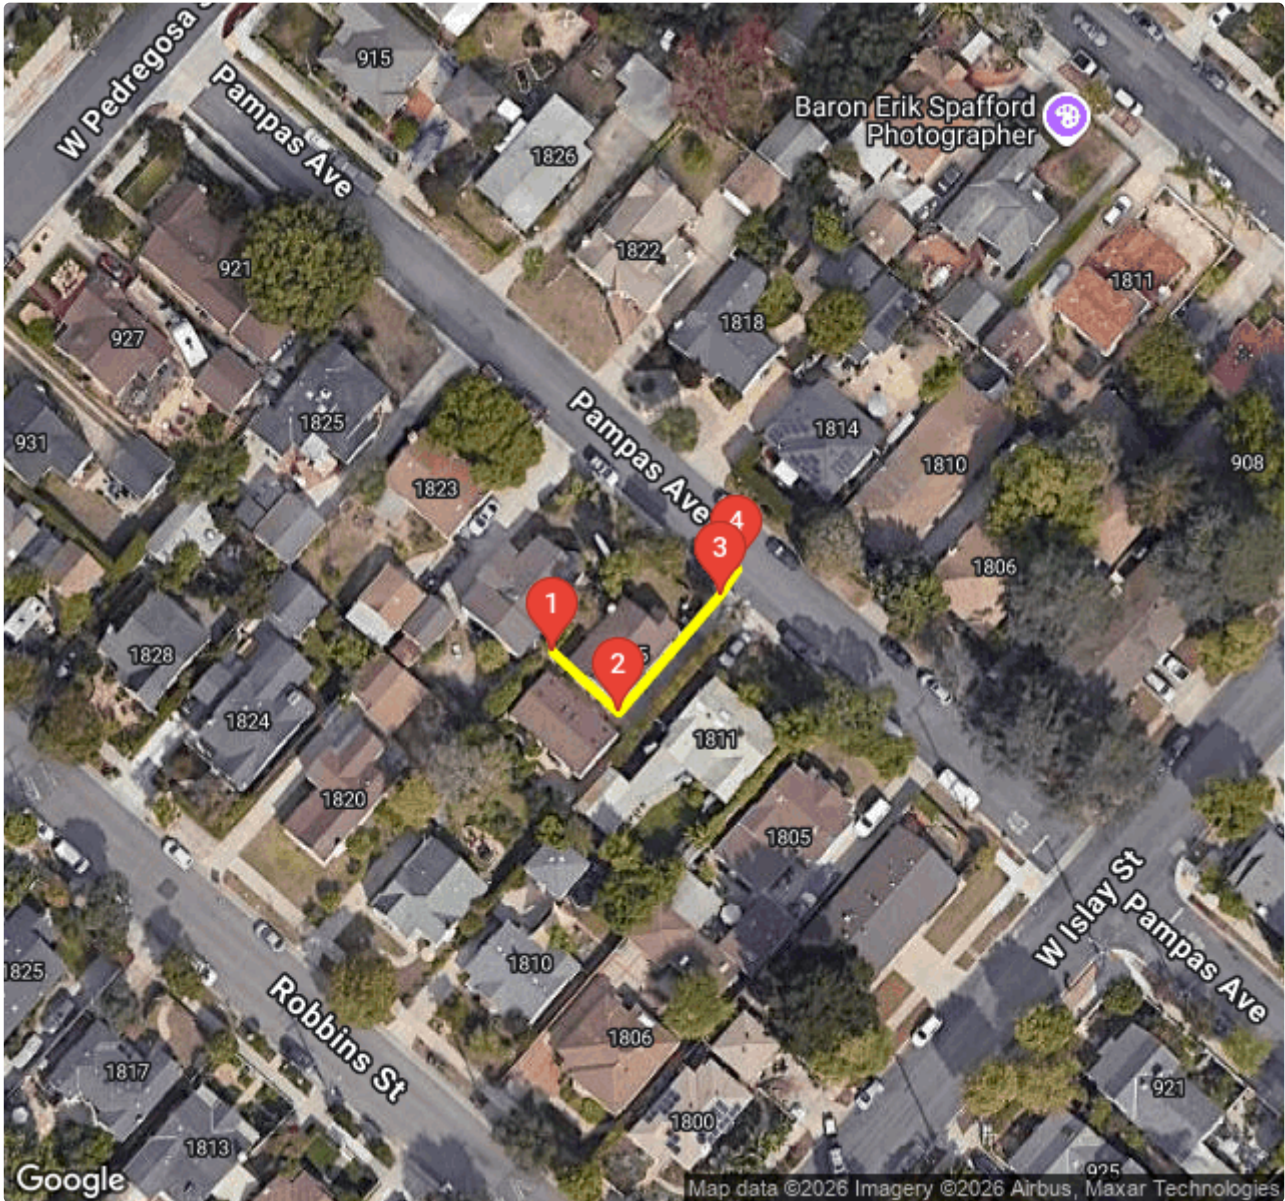
# Property Map

1. Lateral Start
2. ADU cleanout
3. Prop line cleanout
4. Y connection

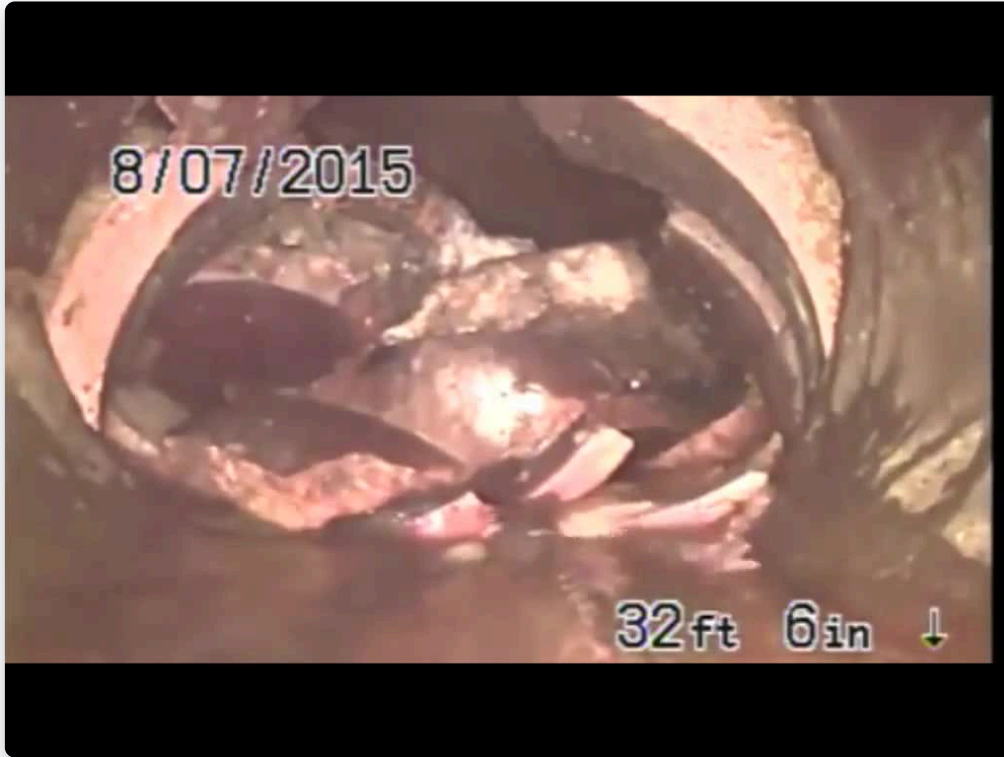
# Sewer Lateral Video

Big collapse. Fix needed.

12.31 seconds | 29.0 feet |  
BROKEN

The sewer lateral inspection at 1815 Pampas Ave reveals multiple significant defects including collapse, broken pipe, offset joints, and root intrusion, all of which violate Santa Barbara Municipal Code Section 34.324 regarding sewer lateral condition and maintenance standards. The pipe material is cast iron, 4 inches in diameter, with a total length of 55 feet, and the inspection was conducted against flow. The presence of these defects indicates the lateral is not functioning properly and is not up to municipal code requirements. The City of Santa Barbara has determined that the sewer lateral requires replacement due to these deficiencies. Therefore, the inspection status is Needs Additional Work. Next steps: - Get multiple bids with plumbing contractors by forwarding the URL link on Forward Lateral. - Select a plumbing contractor and pull permits. - Perform the necessary sewer lateral replacement or repair. - Schedule or submit a final inspection with the City of Santa Barbara to confirm compliance.
