# Sewer Inspection Report

1815 Pampas Ave, Santa Barbara, CA 93101, USA

Aug. 20, 2025

Jesse Aizenstat  
Cojo Canyon Plumbing

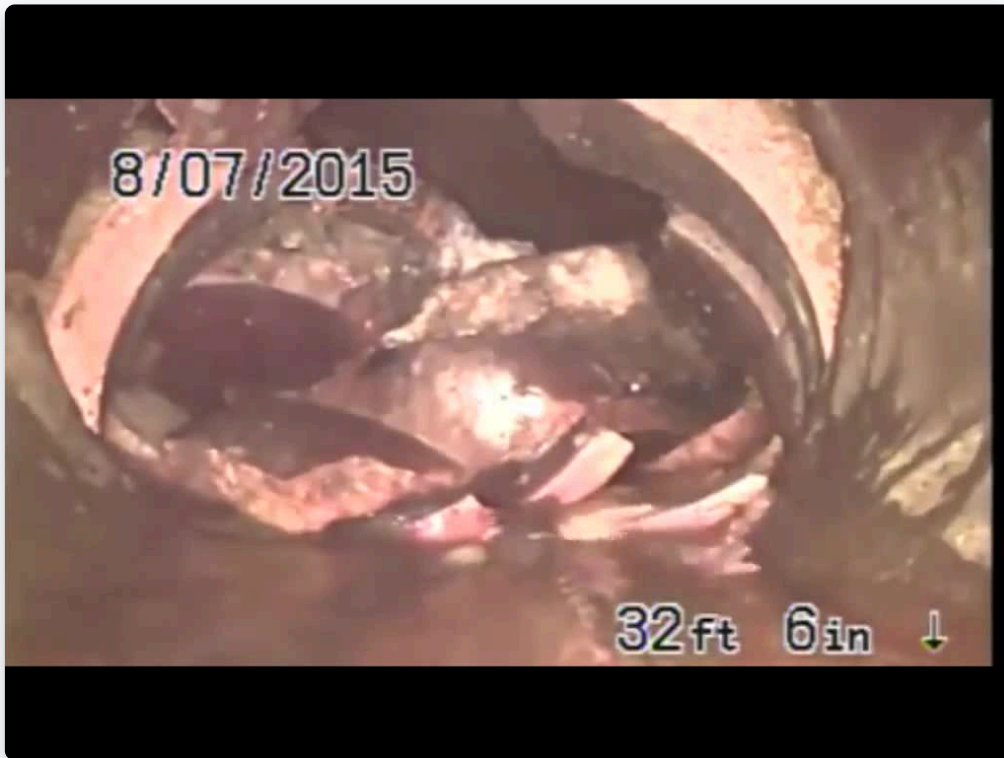
## Sewer Lateral Video

Big collapse. Fix needed.

The sewer lateral inspection at 1815 Pampas Ave reveals multiple significant defects including collapse, broken pipe, offset joints, and root intrusion, all of which violate Santa Barbara Municipal Code Section 34.324 regarding sewer lateral condition and maintenance standards. The pipe material is cast iron, 4 inches in diameter, with a total length of 55 feet, and the inspection was conducted against flow. The presence of these defects indicates the lateral is not functioning properly and is not up to municipal code requirements. The City of Santa Barbara has determined that the sewer lateral requires replacement due to these deficiencies. Therefore, the inspection status is Needs Additional Work. Next steps: - Get multiple bids with plumbing contractors by forwarding the URL link on Forward Lateral. - Select a plumbing contractor and pull permits. - Perform the necessary sewer lateral replacement or repair. - Schedule or submit a final inspection with the City of Santa Barbara to confirm compliance.
