Sewer Inspection Report

2532 Borton Dr, Santa Barbara, CA 93109, USA
#8821

Jesse Aizenstat #8821
Cojo Canyon Plumbing

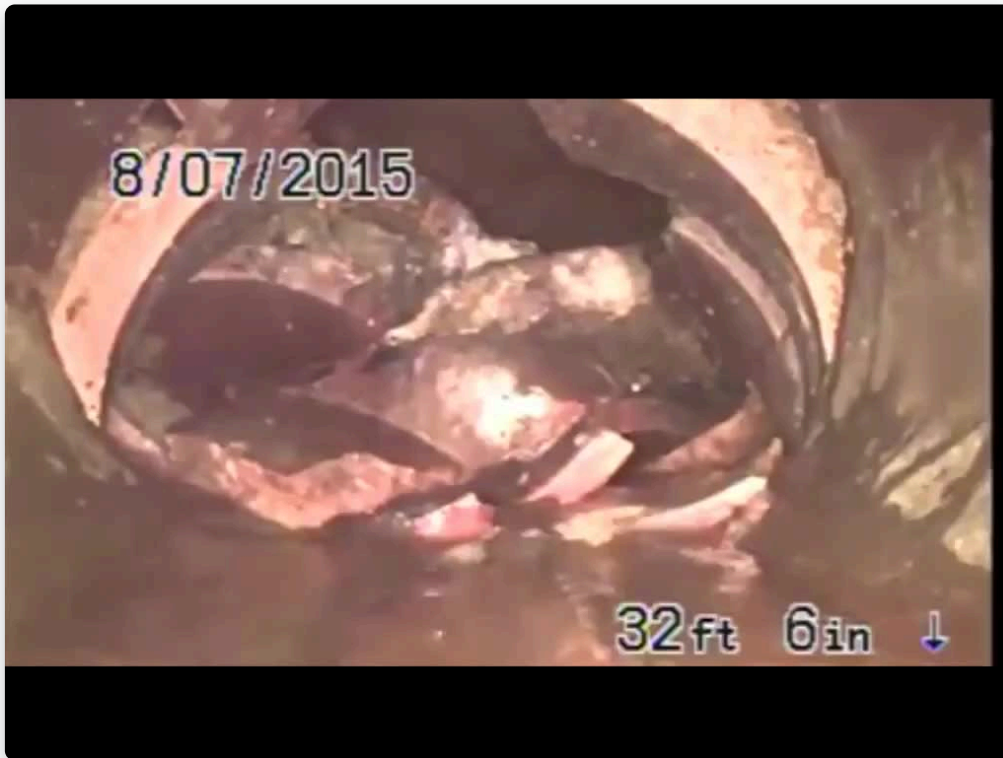
Sewer Lateral Video

Some big roots in there and a collapse.

The sewer lateral inspection at 2532 Borton Dr reveals multiple significant defects including a collapse, offset, broken pipe, and extensive root intrusion (25% to 50%) along the lateral. These conditions violate the Santa Barbara Municipal Code requirements for sewer lateral integrity and functionality, which mandate that laterals be free of structural damage and obstructions to prevent sewage leakage and backups. Due to these defects, the inspection does not pass and the lateral requires repair to comply with municipal standards. The presence of a cleanout accessible outside the building and at the sidewalk is positive, facilitating repair work. Next steps: - Get multiple bids with plumbing contractors by forwarding the URL link on Forward Lateral. - Select a plumbing contractor and pull permits. - Perform the necessary repairs to address collapse, offset, broken pipe, and root intrusion. - Schedule or submit a final inspection with the City of Santa Barbara to confirm compliance.
